FB 711

C.R. 130
Sta. 125+00 to C.R. 37
Harrison Twp., Logan Co., Ohio

125+00 - P.I. - R.R. Spike
set on the split of the two
R/W monuments found -
start of this survey -
Ref: R/W Plan L-27

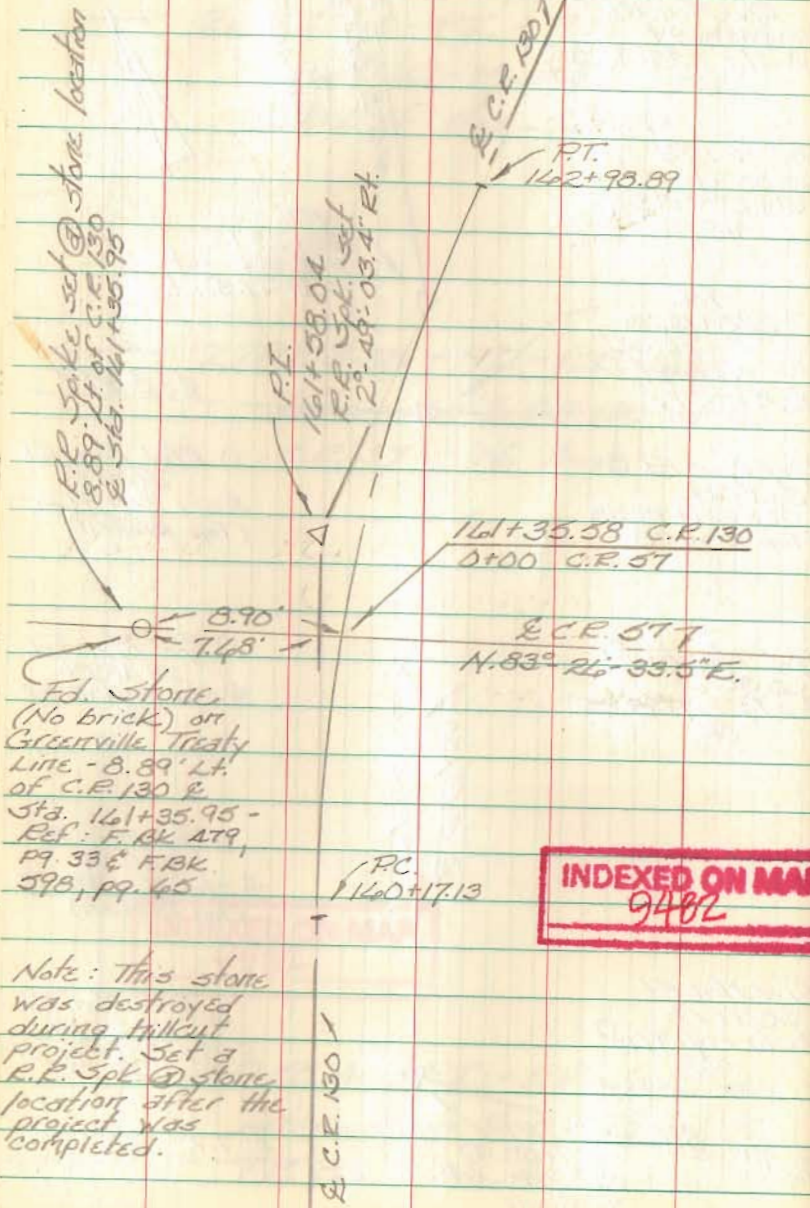
Intersection C.R. 130 W/ C.R. 57

Note: This stone was destroyed during hillcut project. Set a R.P. 5pk @ stone location after the project was completed.
