Part Lot 1169
Bellefontaine, Ohio
November 3, 1973

PART LOT 1169
 BELLEFONTAINE, OHIO
 FOR
 MRS. B.O. BEATTY
 NOV. 3, 1973
 SCALE 1"=20'

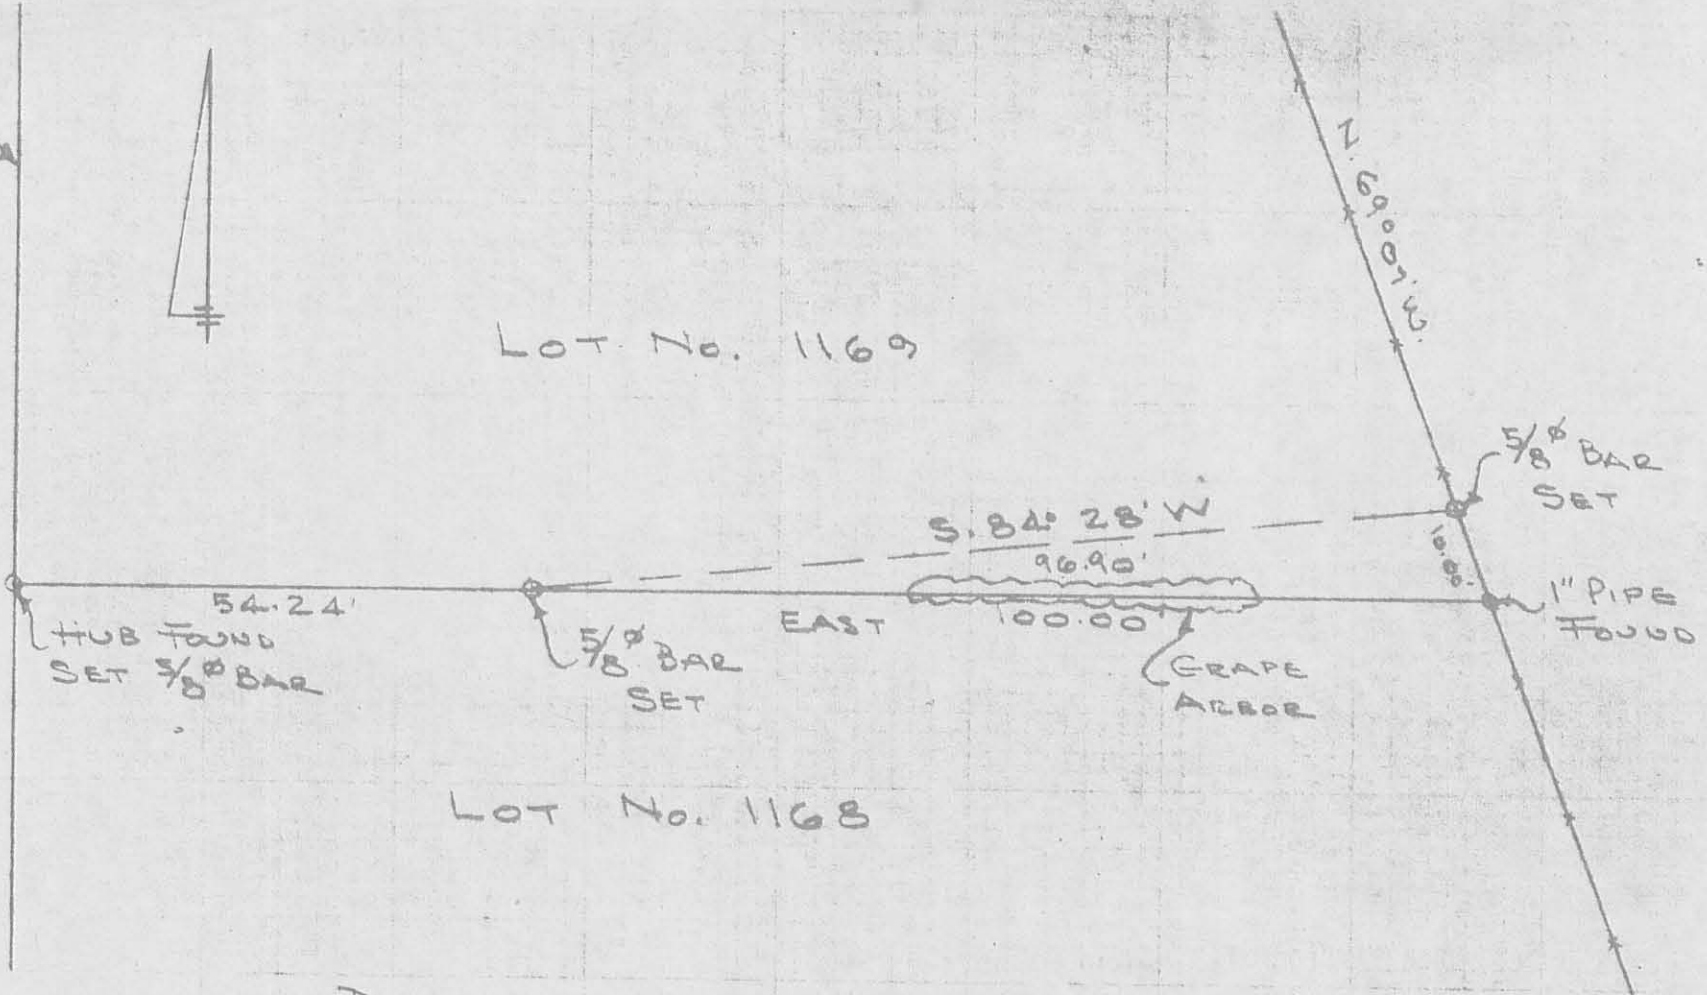
Commencing at an iron bar in the east line of Madriver Street at the southwest corner of said lot 1169; thence with the south line of said lot East 54.24 feet to an iron bar, said iron bar being the beginning point of this description; thence continuing with said south line East 100.00 feet to an iron pipe at the southeast corner of said lot; thence with the east line of said lot 1169 N. $69^{\circ}07'$ W. 10.00 feet to an iron bar; thence S. $84^{\circ}28'$ W. 96.90 feet to the place of beginning.

MADRIVER ST.
#0
#2
#4
#6

LOT No. 1169

LOT No. 1168

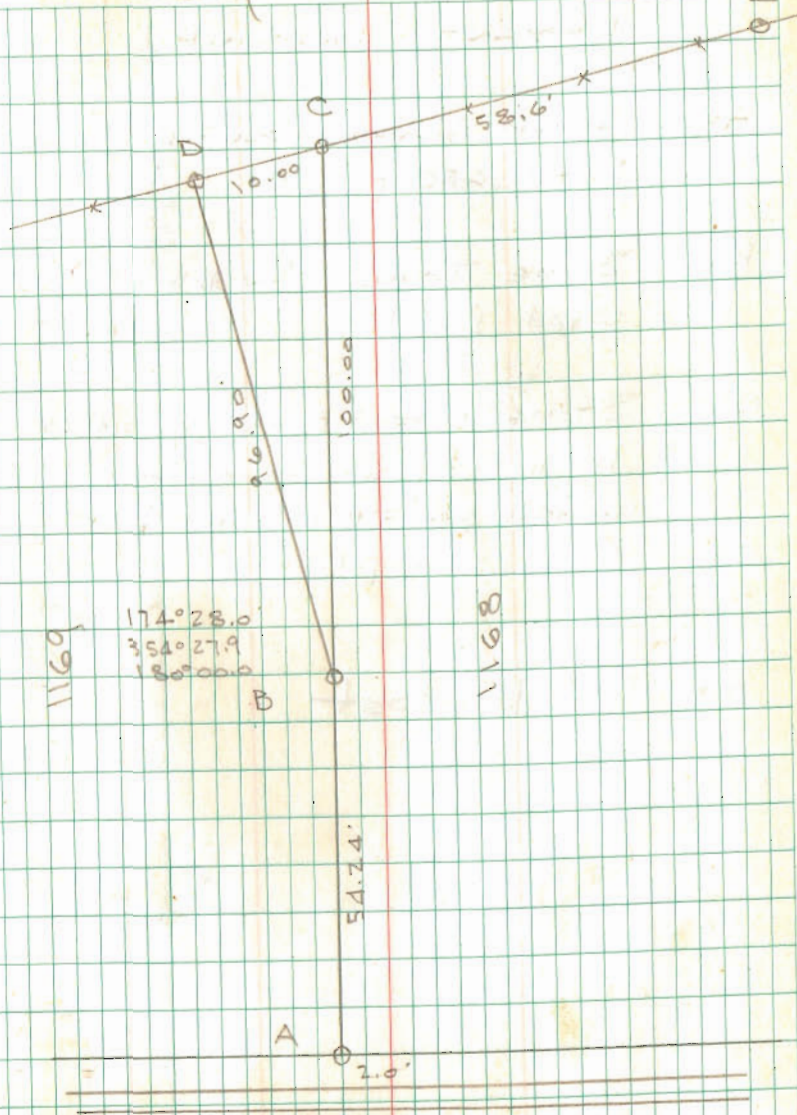
SURVEY OF NORTH LINE
 LOT 1168
 BELL FOUNTAIN

A = Remains of Hub Found
 Set $\frac{5}{8}$ " Bar

B $\frac{5}{8}$ " Bar Set

C = 1" Pipe Found

D = $\frac{5}{8}$ " Bar Found

E = $\frac{1}{2}$ " pipe Found

See City Bk 248, pg 54-55
 For Survey of Lot 1168
