GOLLIDAY TRUST SURVEY
 N.E. 1/4 SEC. 6, T 7S, R 8E
 STOKES TWP., LOGAN CO., OH

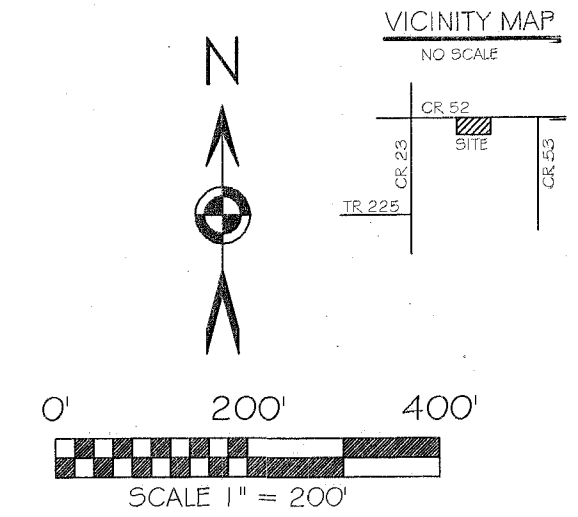
BASIS OF BEARING: BEARINGS ARE BASED ON THE OHIO DEPARTMENT OF TRANSPORTATION V.R.S., OHIO STATE PLANE NORTH ZONE, 3401, NAD 83(2011 ADJ) WITH THE NORTH LINE OF THE NORTHEAST QUARTER BEING S 89°00'38" E.
